CASING REPAIR SYSTEMS

Inflatable Packers International

Casing Repairs

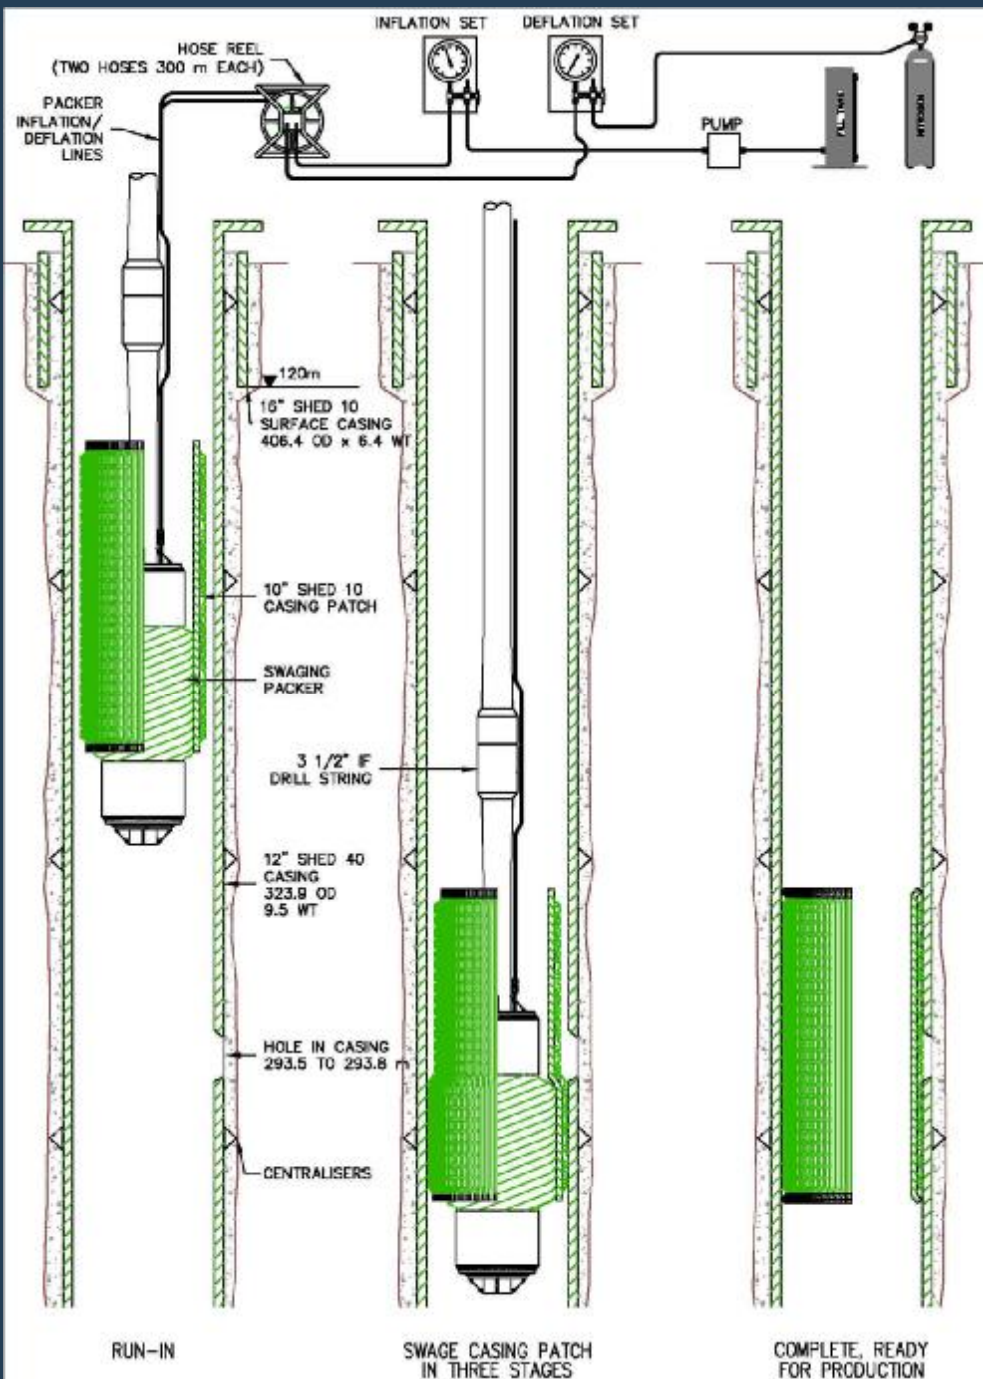
Figure 1
- Patching a
single hole
in the casing
with a
Swage Patch

- Our Swage Patches consist of a rubber covered length of thin wall pipe that is permanently deformed by a high pressure packer to create an internal casing patch.
- The following slides show the two most usual applications; a single patch and a straddle patch.

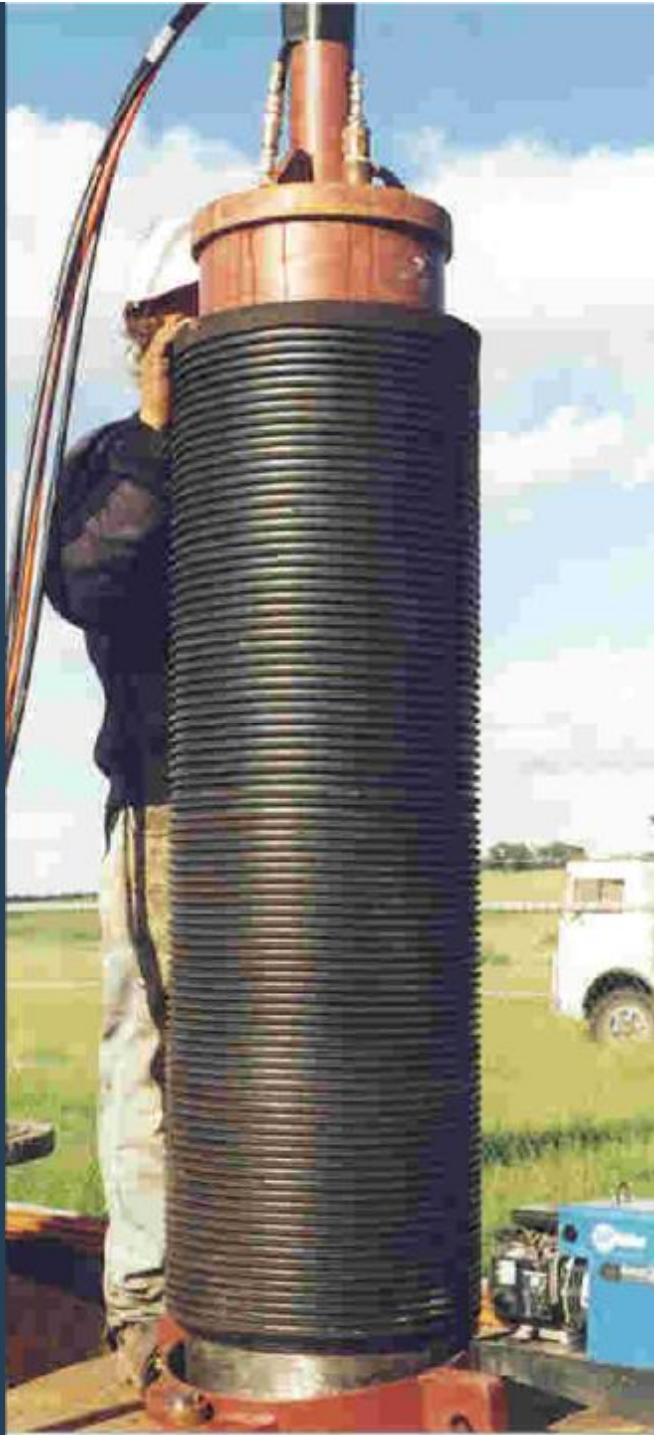
*An example
of a Swage
Patch being
run in a 14"
well in
Victoria*

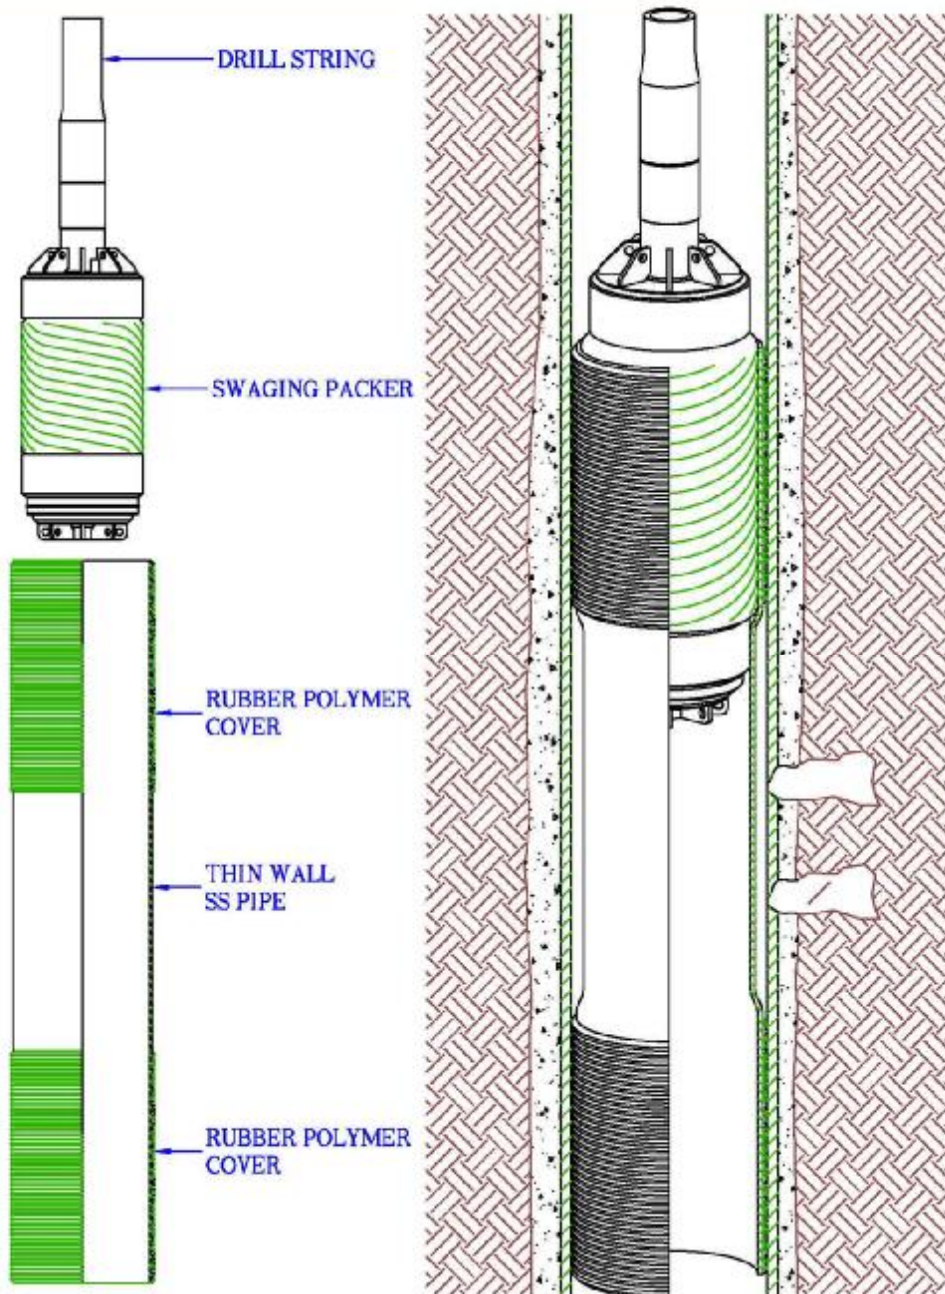
Figure 2
- Patching a series of holes in the casing with a Swage Patch

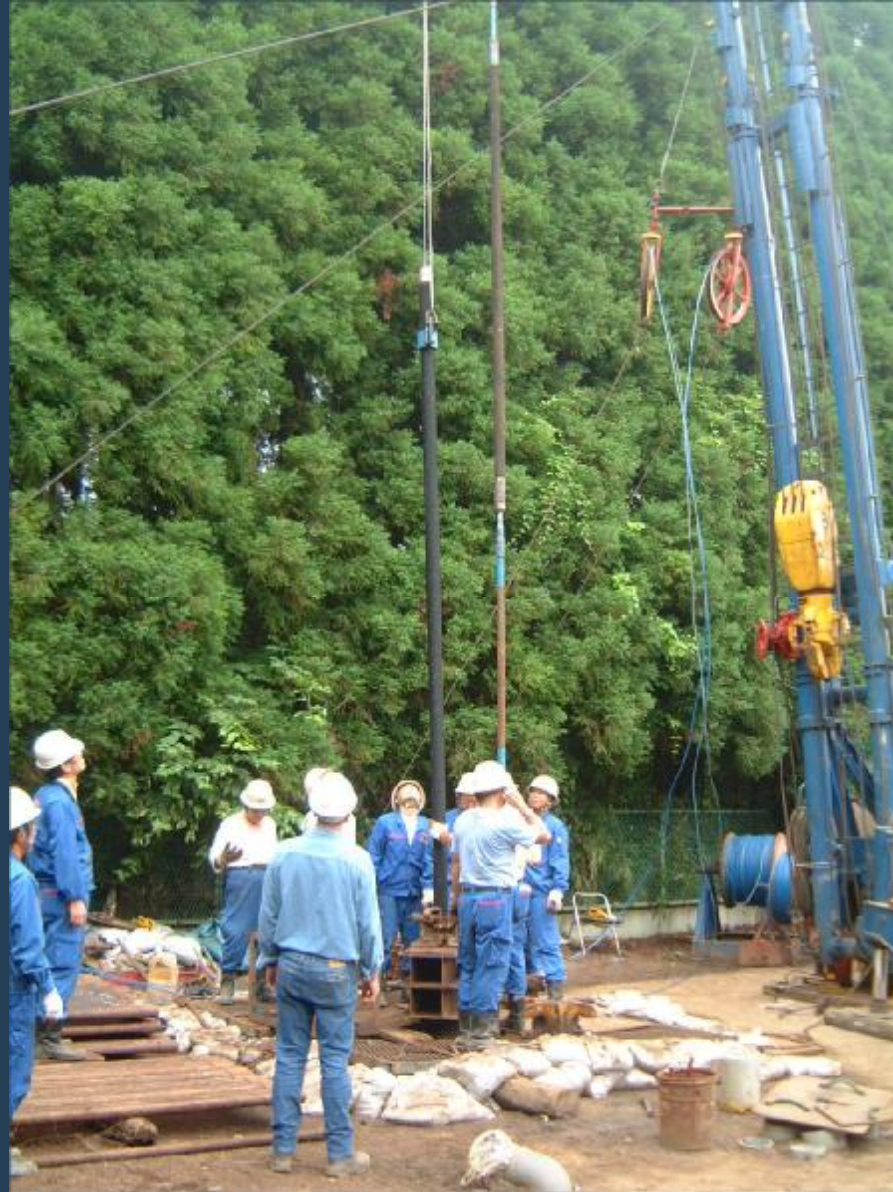
- The following shows a series of photos taken during installation of 6 & 12 metre long patches in a 5-1/2" gas production well in Japan.
- The patches are based on 3" Sch 10 stainless steel pipe with a 4 mm thick vulcanized rubber cover.

6 m long patch being lowered into the well
with HP Swaging packer alongside.

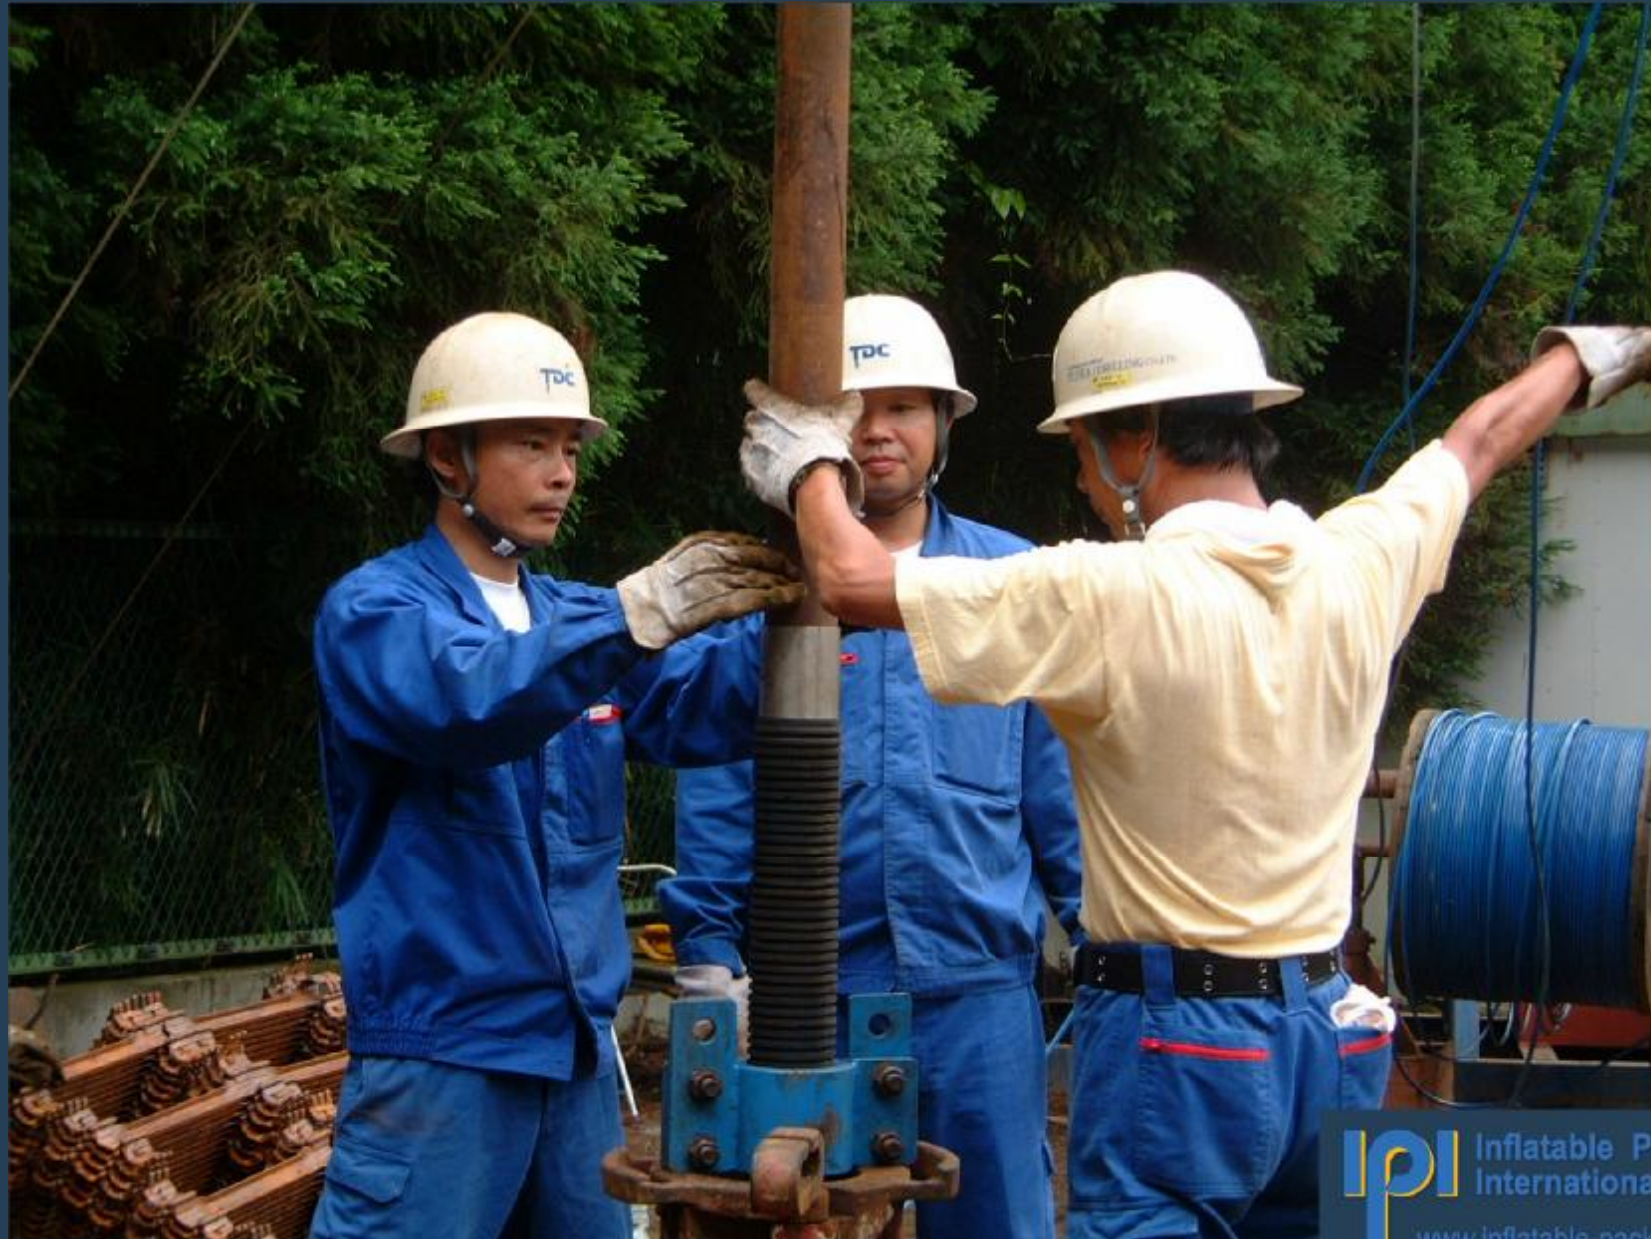
The HP Packer being lowered into the patch

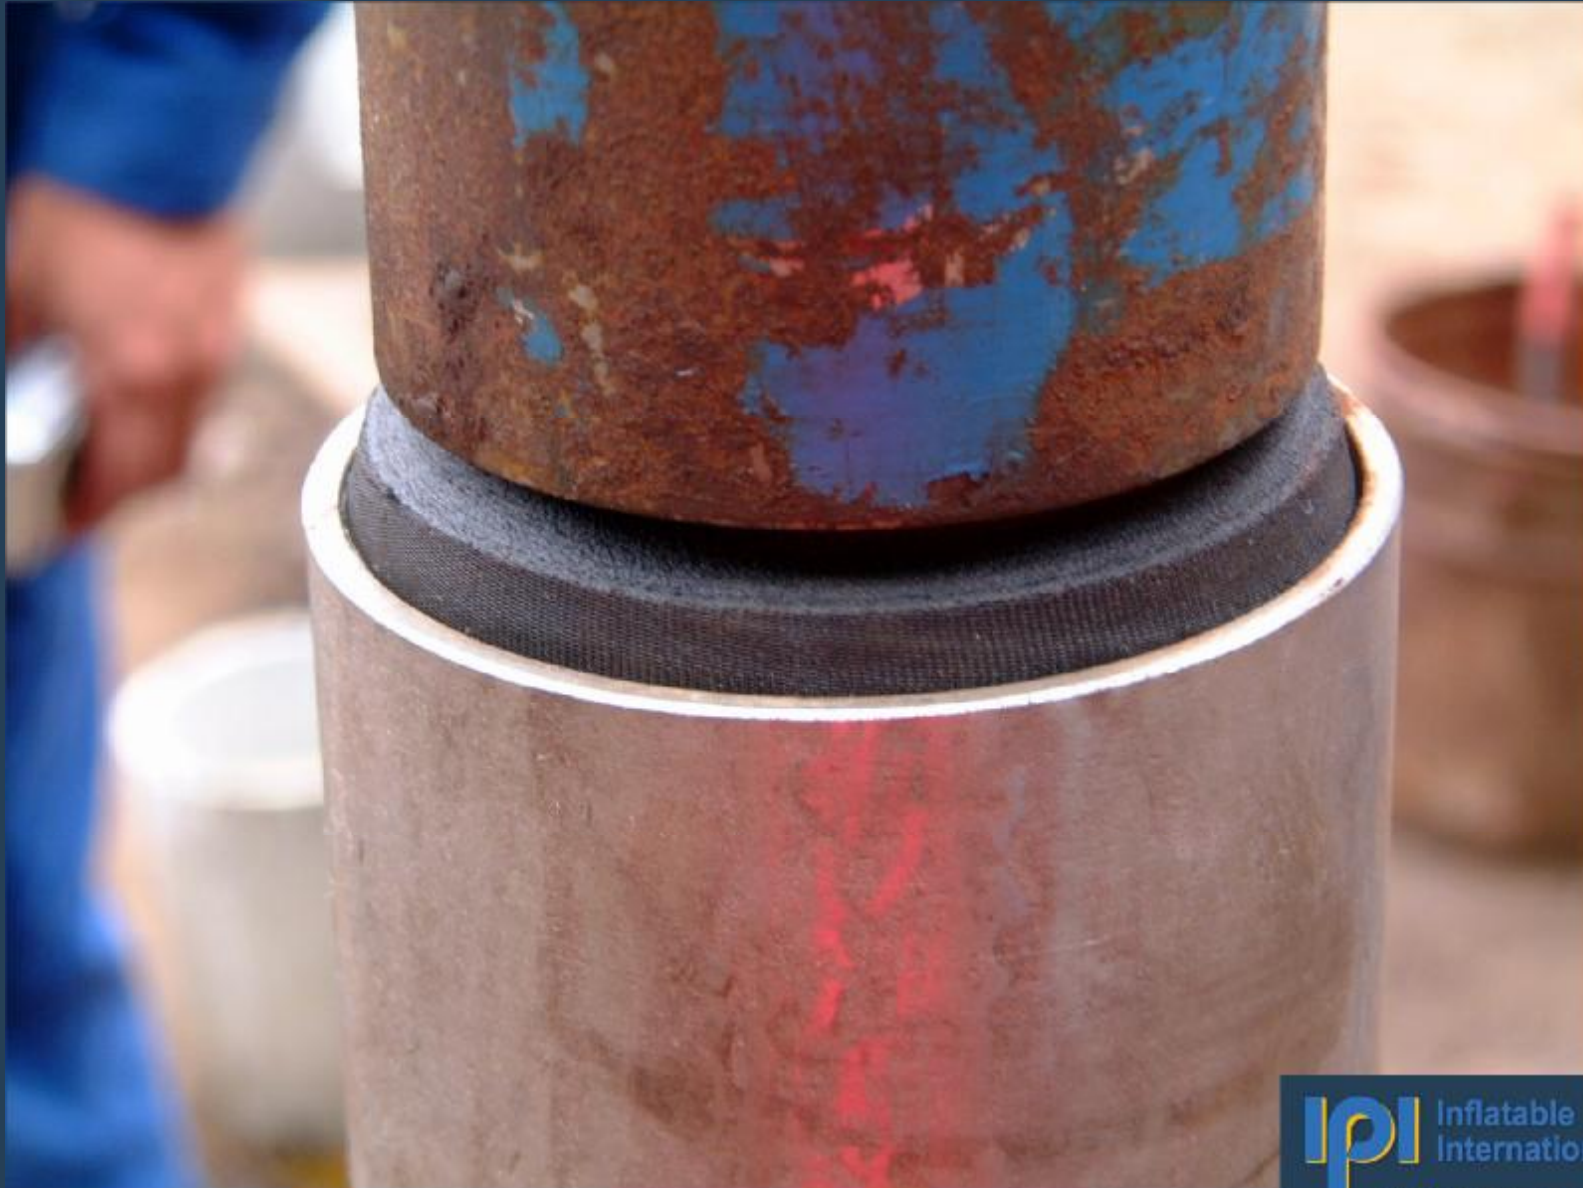
Next, the HP packer is inflated to support the patch

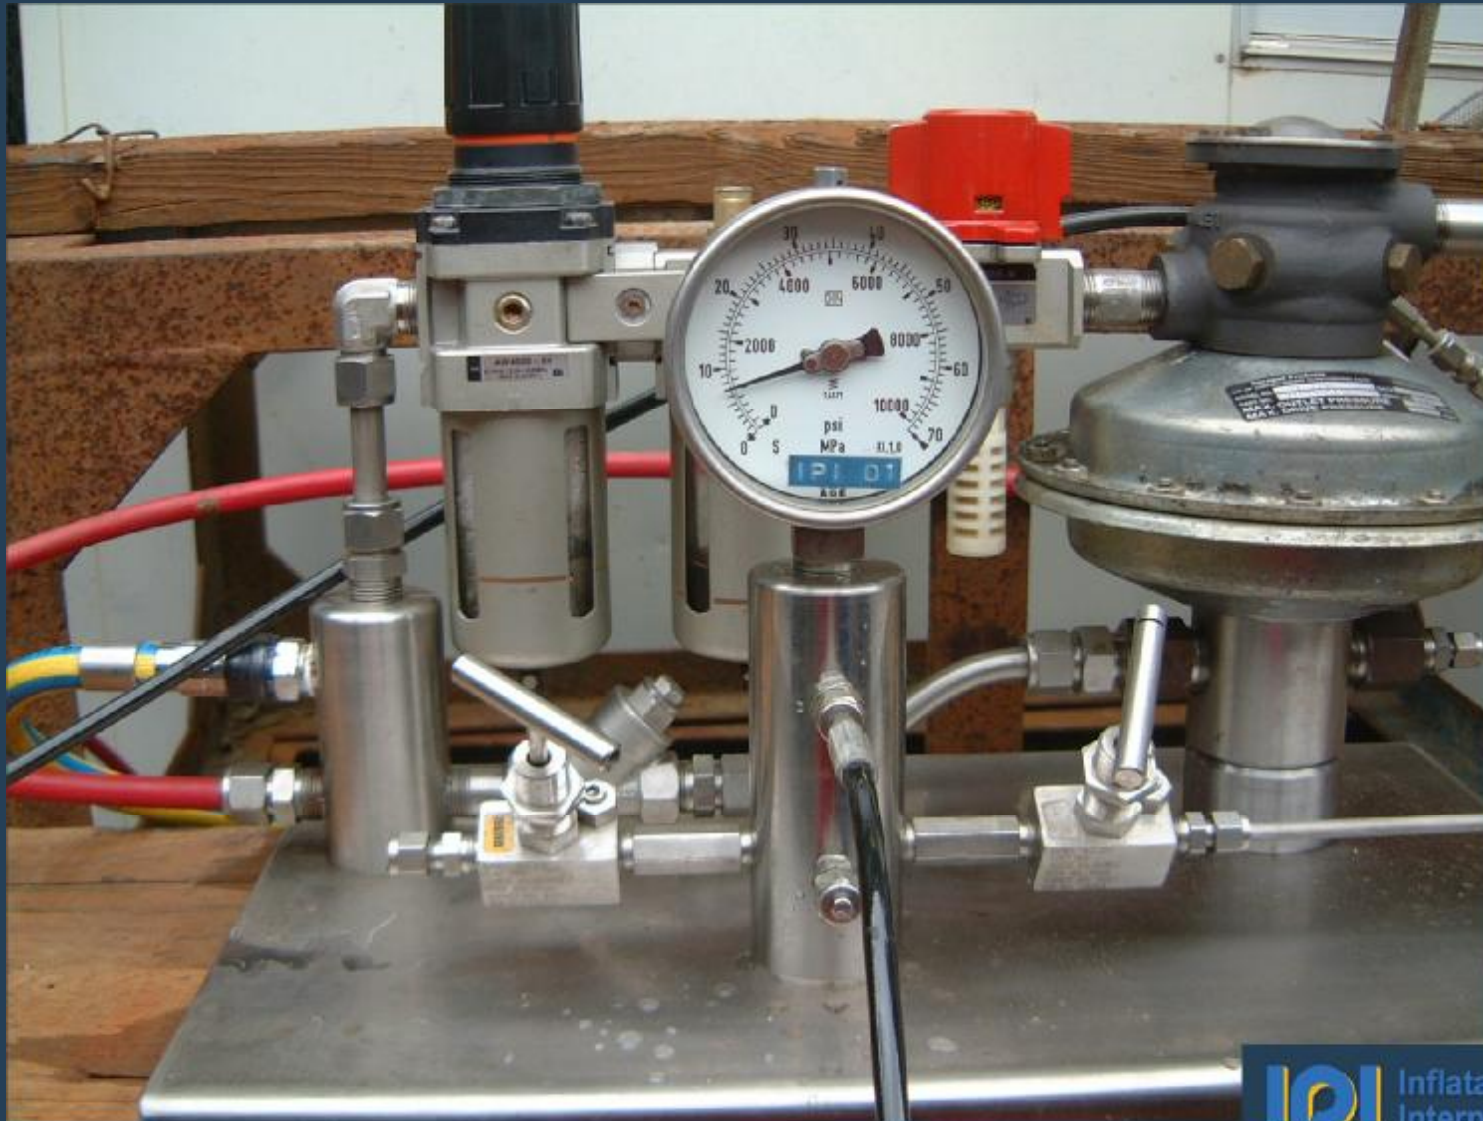
The HP inflation pump used for initial and final packer inflation.

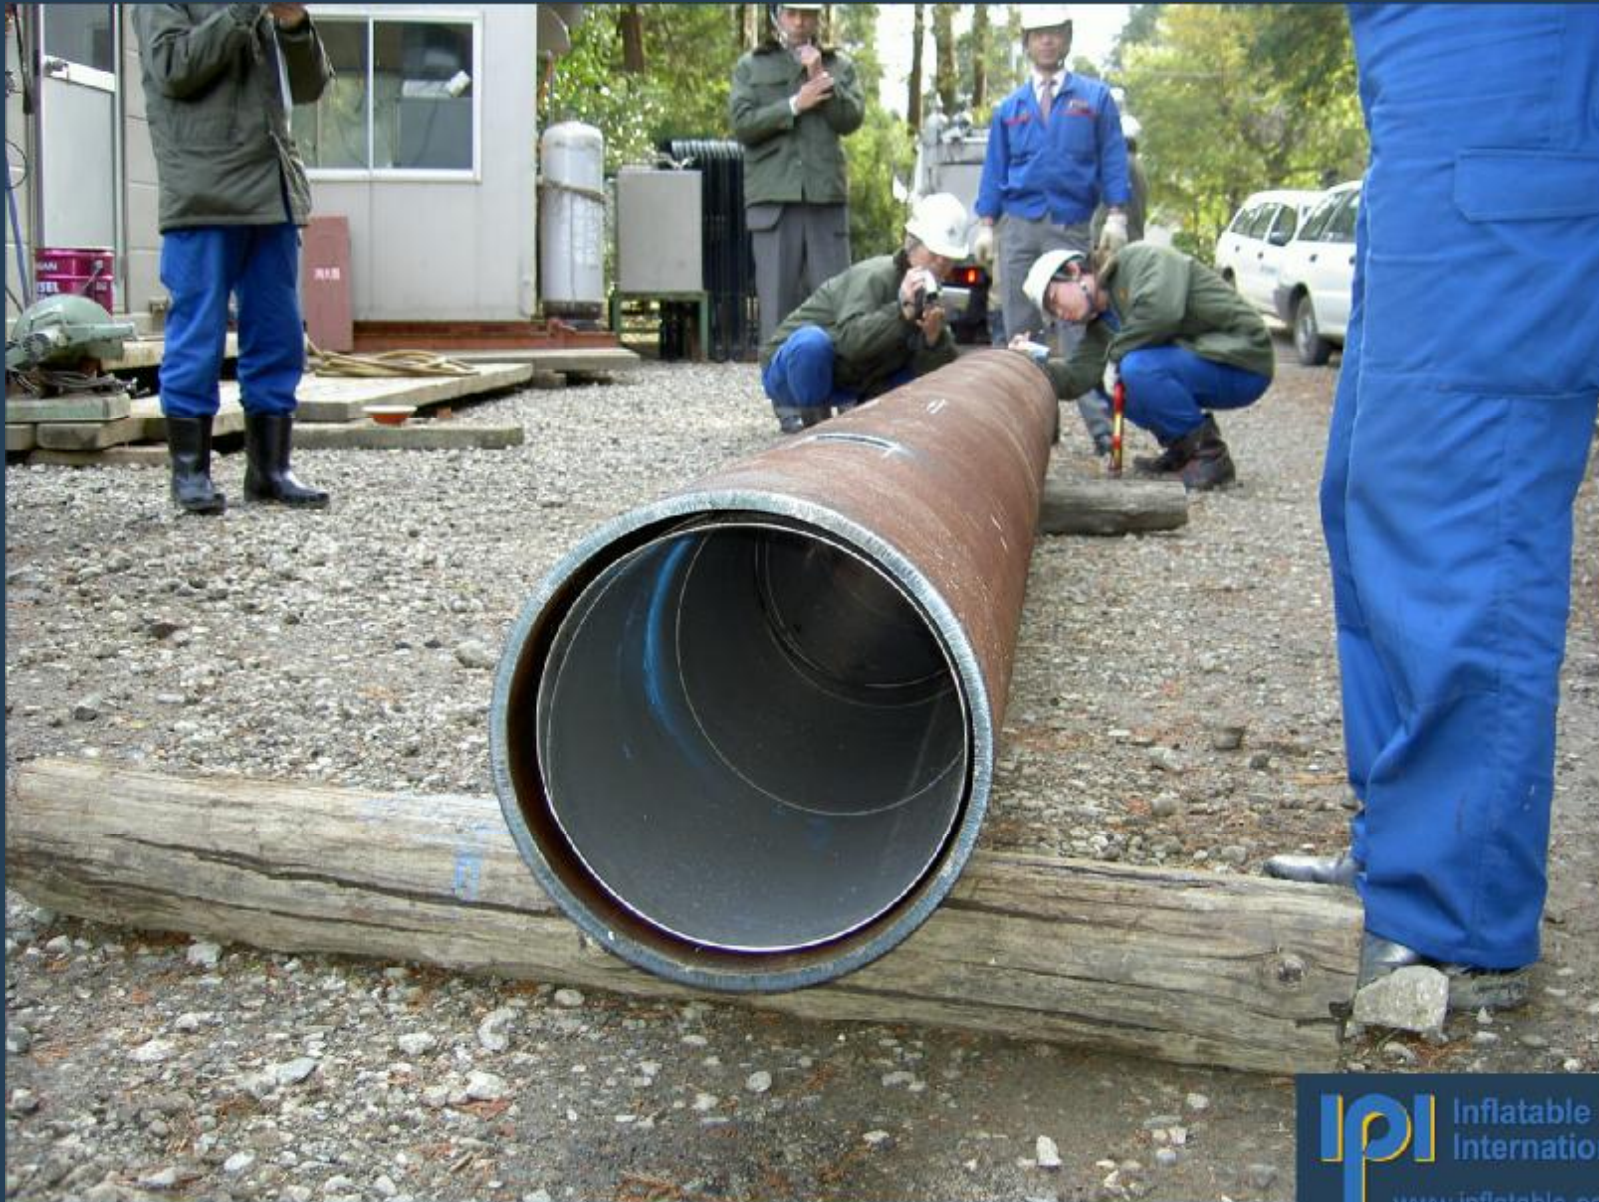
The remainder of the process is illustrated in the following series of photos which were taken during demonstration of our Swage Patch system in Japan for an earlier job. This was a patch based on a 12" OD x 1/8" WT stainless tube with a 6 mm thick vulcanized rubber cover.

This shows the patch installed in the 13-3/8" casing with both lying horizontal on surface.

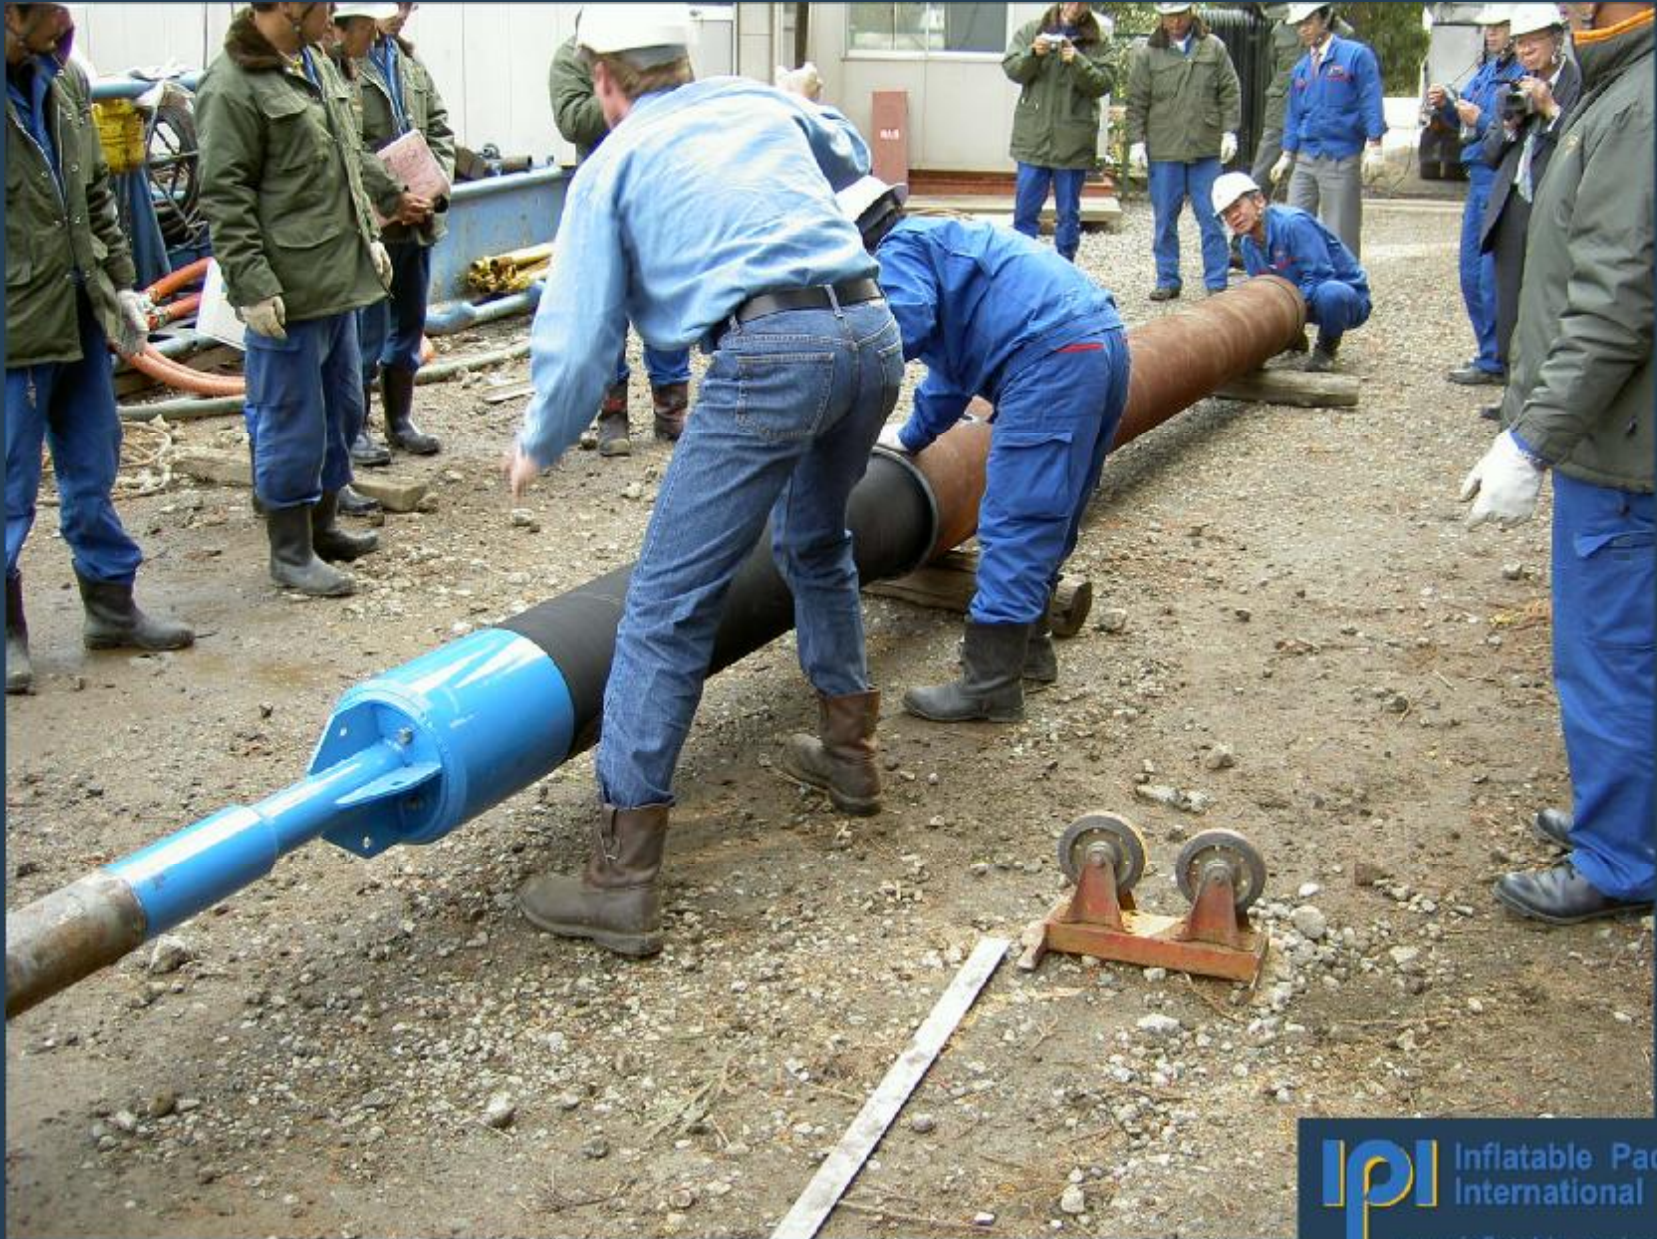
Installing the HP Packer into the patch

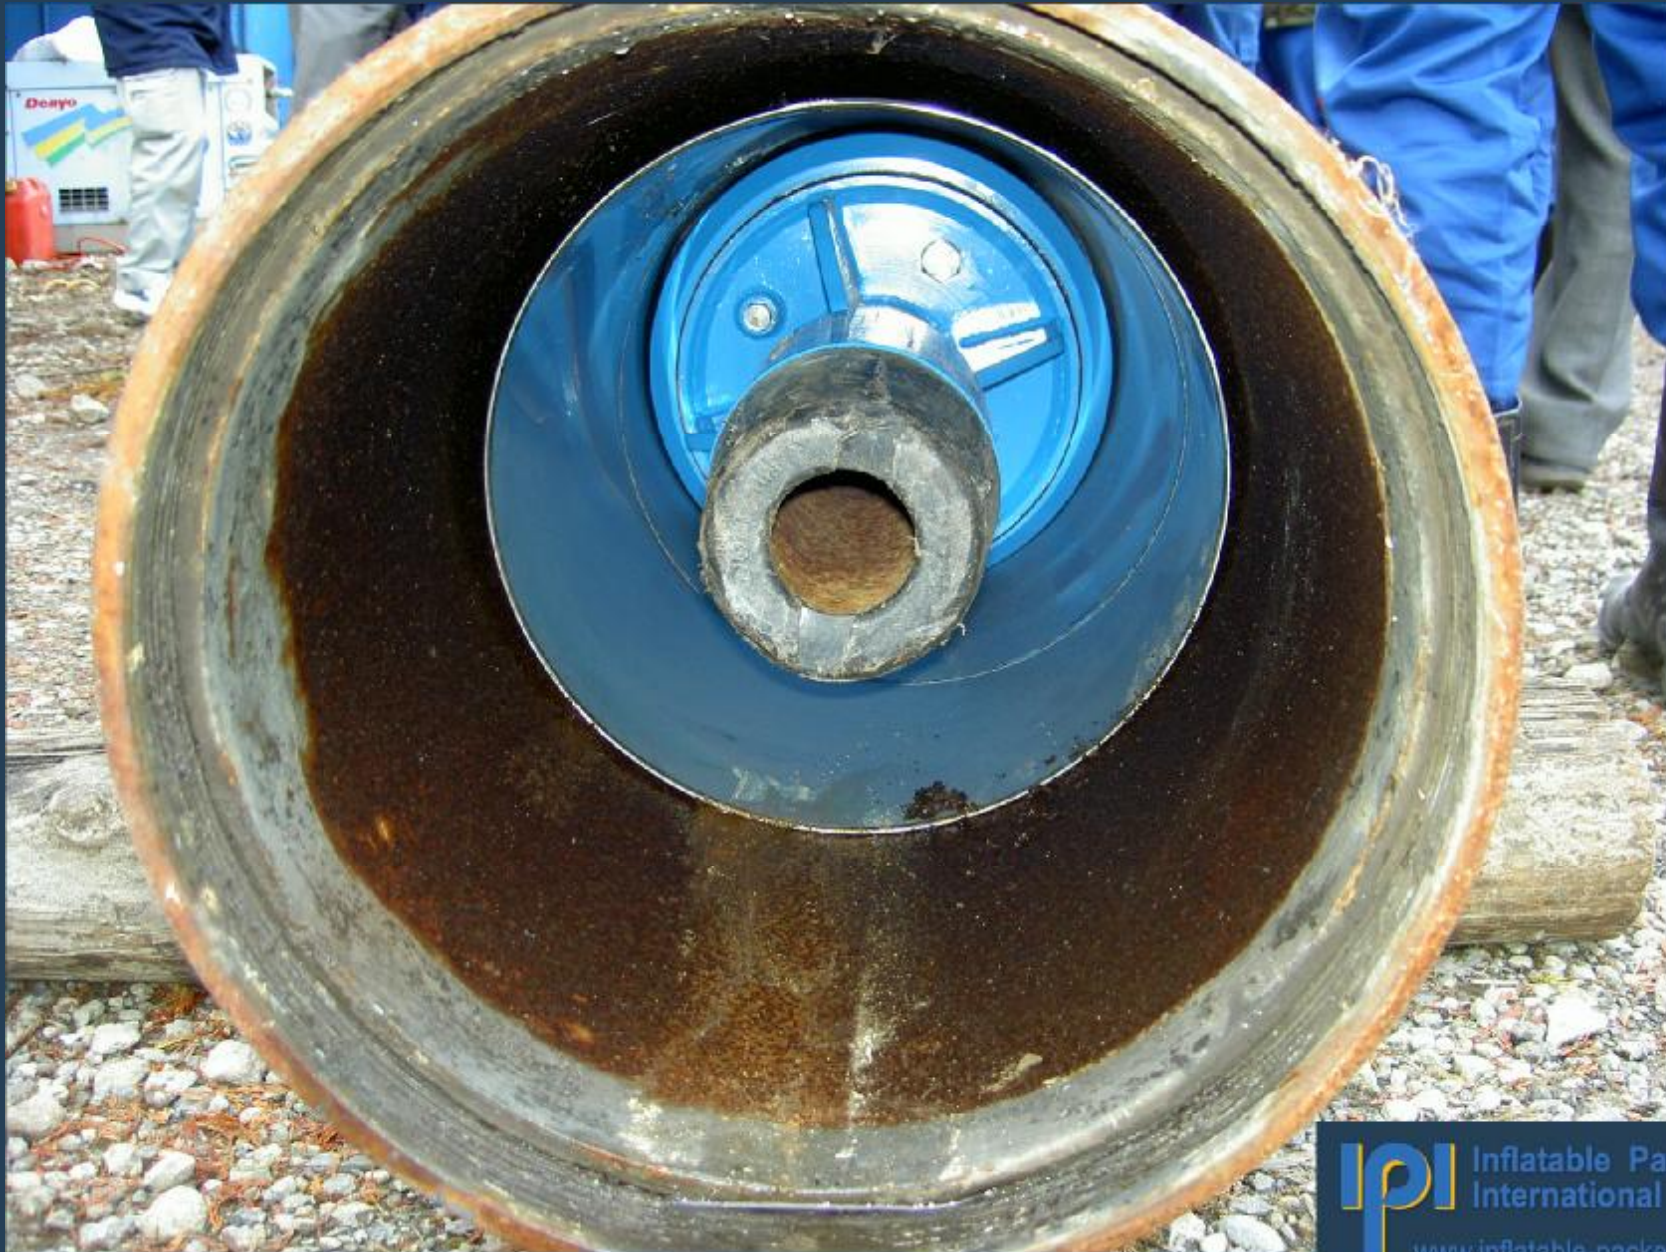
The casing, patch and packer before swaging

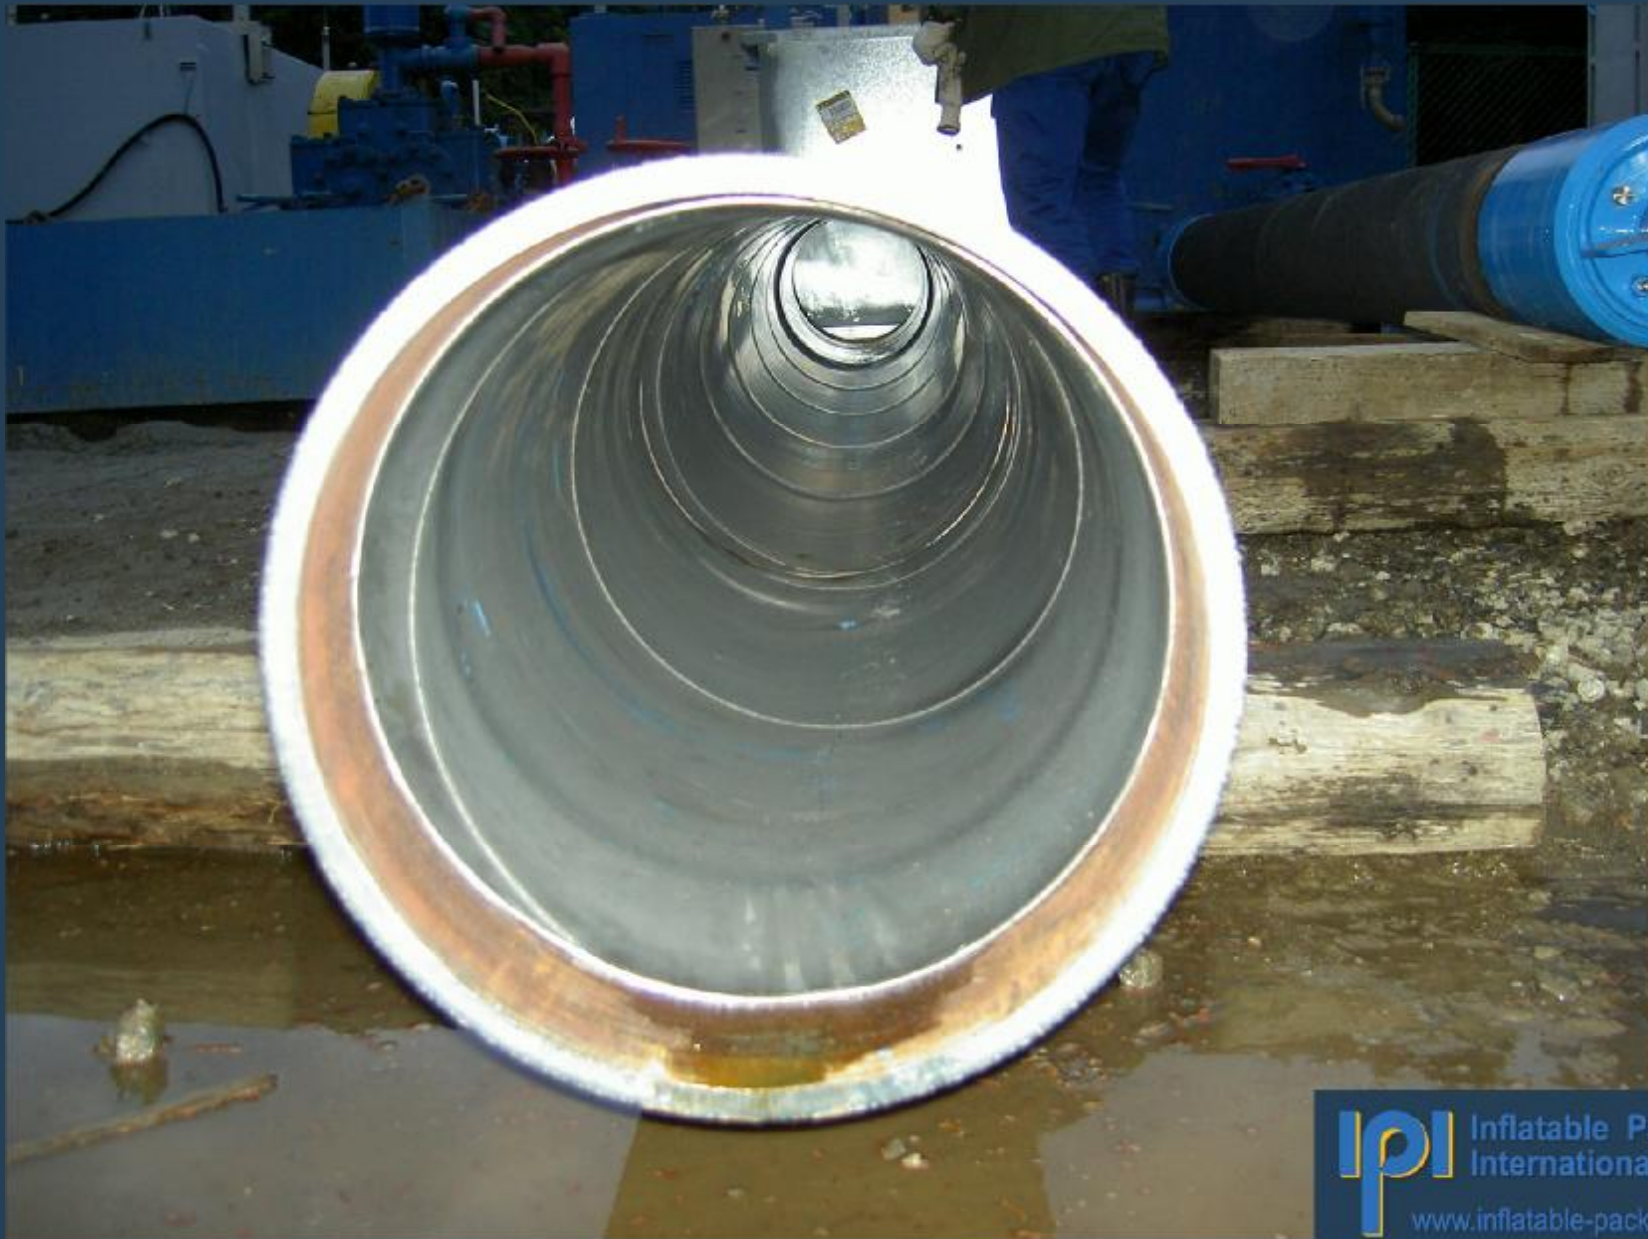
And after swaging with the HP Packer removed

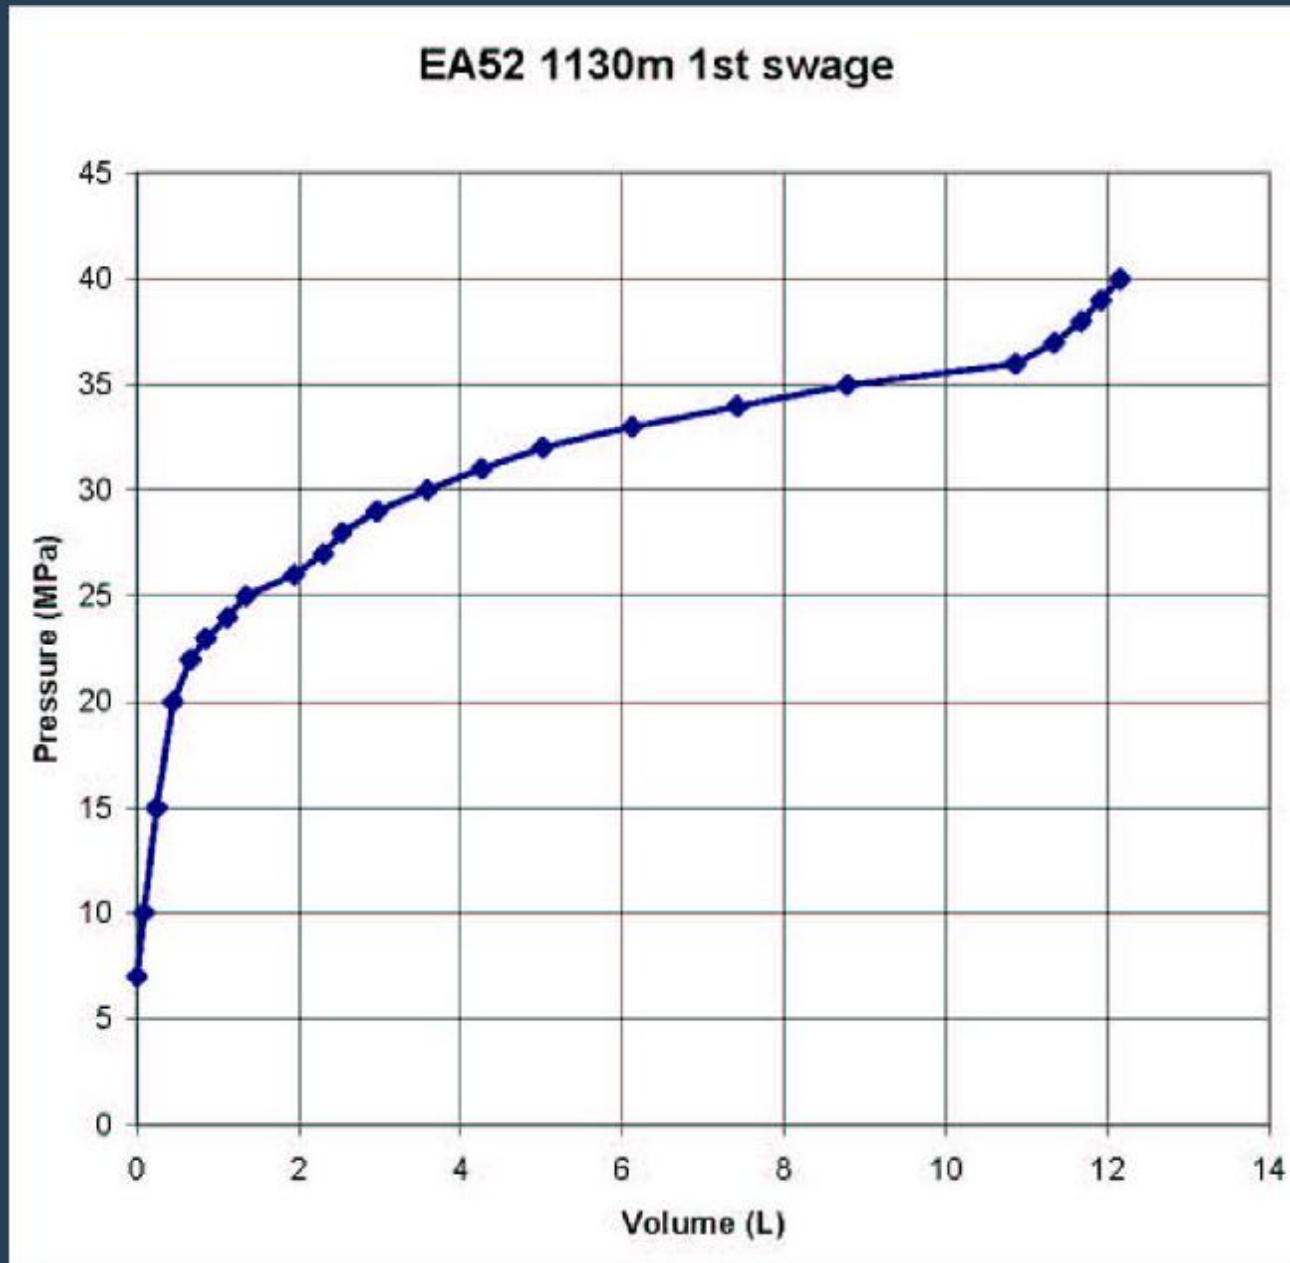
Typical P vs V chart for Swaging

Referring to the chart, it clearly shows the different stages of swaging.

- 1st steep section pressure up to patch yield
- 2nd (the largest portion) the patch swaging
- 3rd (the turn up at the end) is the patch hitting the casing wall and compressing the rubber on the patch OD

By monitoring the high pressure swaging packer's pressure and the volume of the inflation fluid, very precise control is maintained over the swaging process.

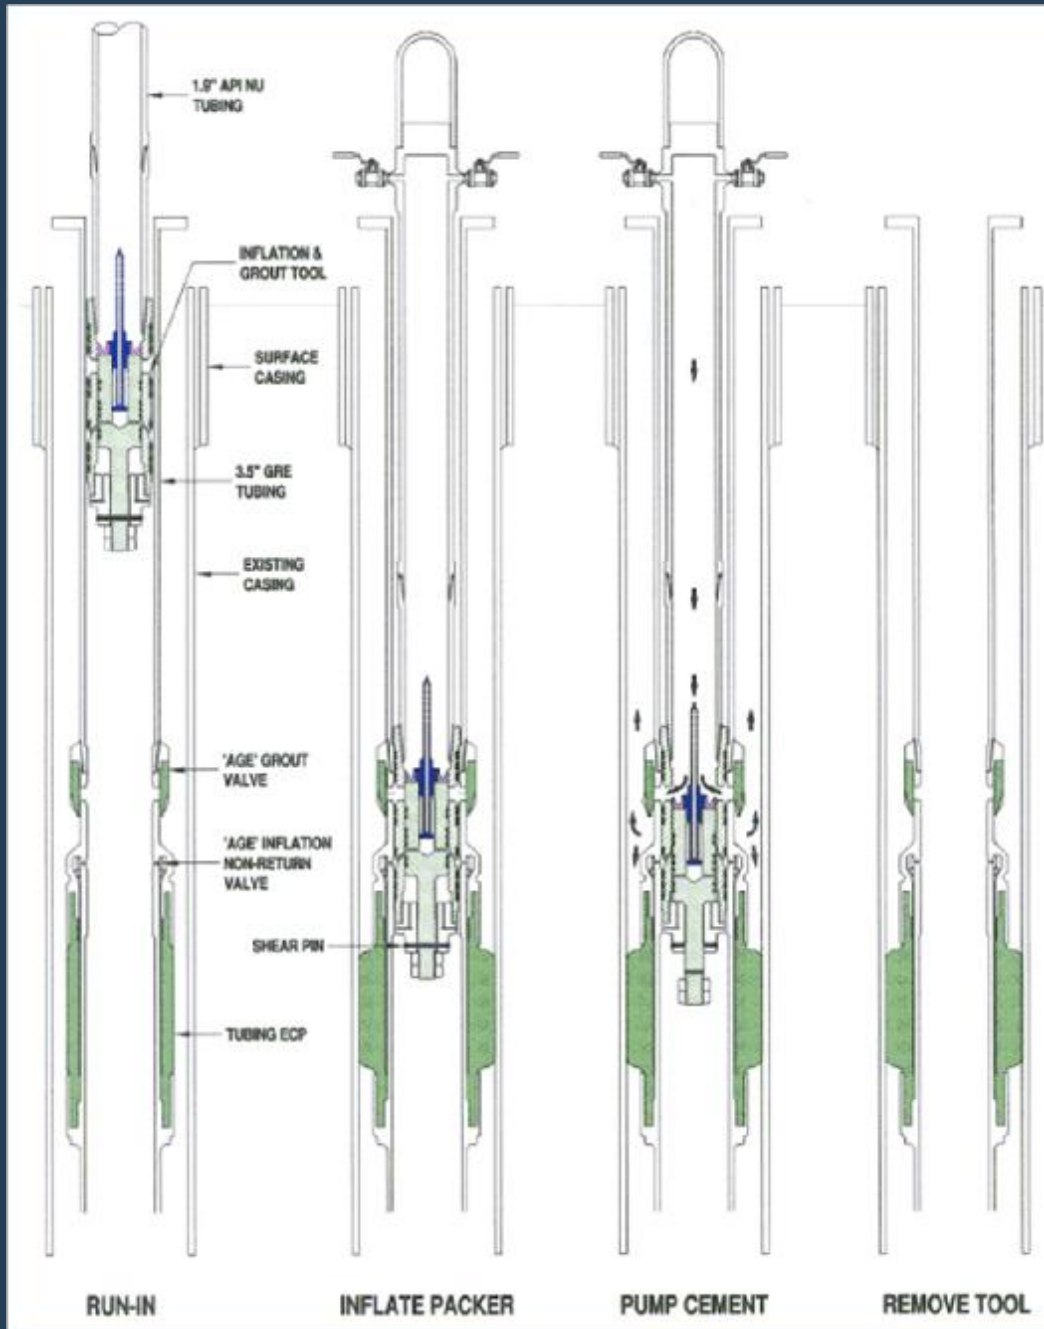
Figure 3
- using a mechanical tool for packer inflation and cementing.

The repair system employed is shown schematically on the attached drawing. In essence, it involved:

- Running a 75 mm NB stainless steel liner to seal via an AGE M-Packer, at the top of the existing screen riser and extending back to within 120 metres of the surface. At this depth the liner is converted to 100 mm NB stainless steel pipe which runs back to surface.

- The liner incorporates an inflatable packer and grouting valve on the base immediately above the screen seal.
- After correct positioning of the liner was verified by downhole video camera inspection.

- A grouting string with a series of mechanical seals and a shear activated valve system was stabbed into the new liner adjacent to the top of the inflatable packer.

- The liner packer was inflated by pumping down through the grouting string. At a factory pre-set pressure of 1000 psi, the shear valve activated automatically shutting off the packer inflation port and opening communication to the liner/casing annulus through the grout valve.

- Pumping of water was continued to ensure that the annulus was free and unblocked. Once confirmed, the liner was then grouted into the old casing by pumping cement grout down the grout string and via the grouting valve into the annulus.

- Cement remaining in the string after grout returns were noted at the surface was displaced into the annulus by pumping water after the cement.
- After waiting for the cement to reach initial set, the grouting string was removed leaving the bore ready to produce.
