CASING REPAIR SYSTEMS

Inflatable Packers International

Casing Repairs

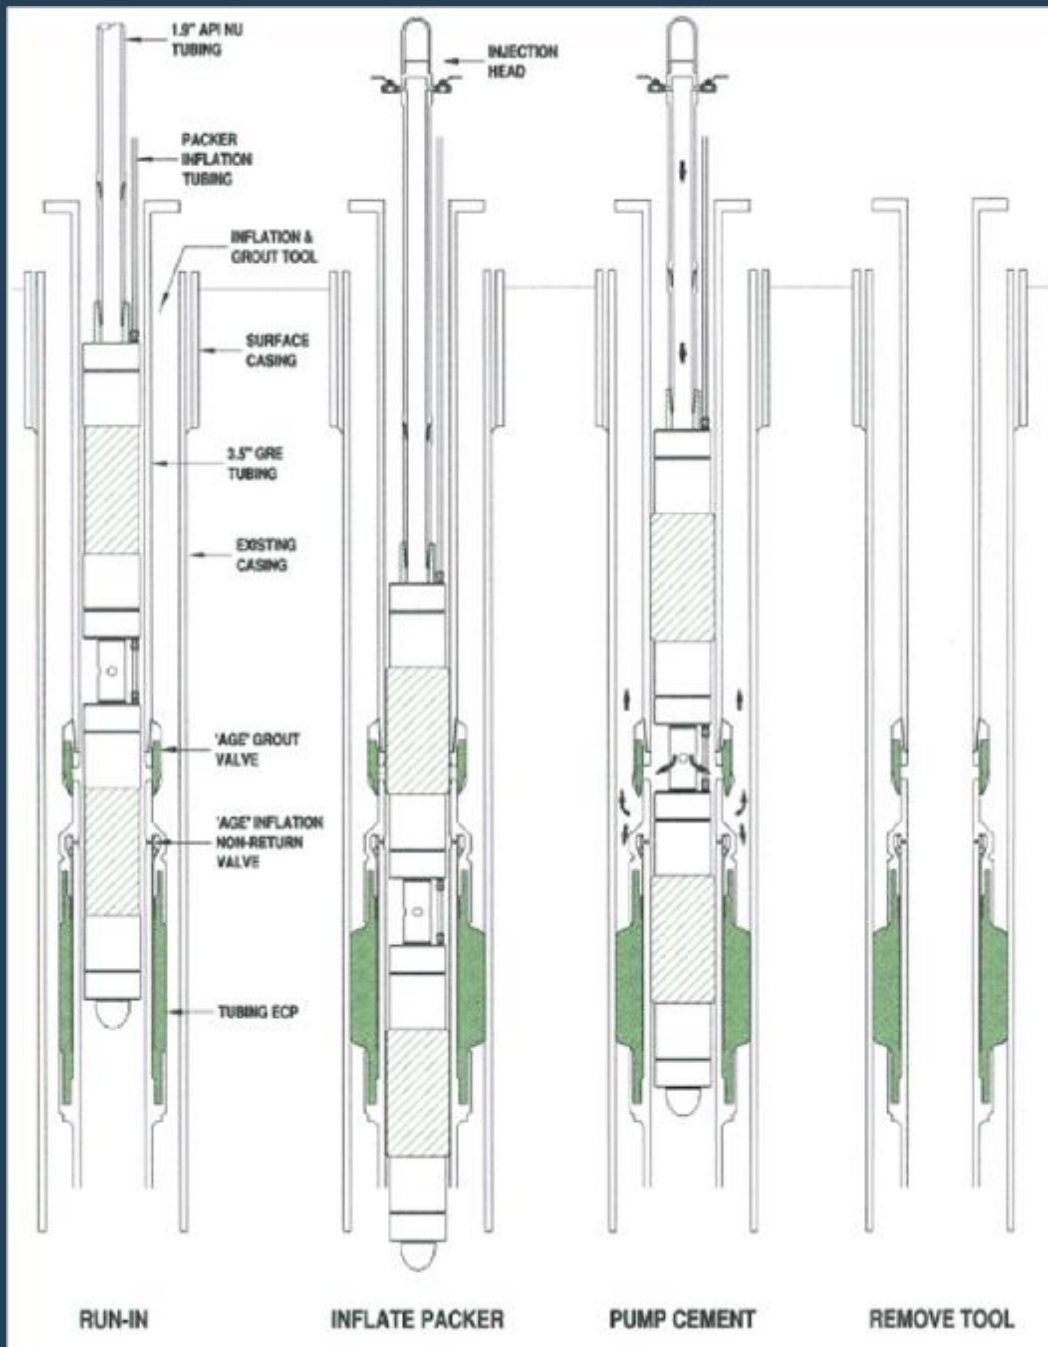
Figure 4
 - using an inflatable straddle packer for inflation and cementing

The repair system designed by AGE Developments is shown schematically on the attached drawing. In essence, it involves:

- Running a 200 mm NB stainless steel liner to seal via an AGE M-Packer, at the top of the existing screen riser and extending back to surface.
- The liner incorporates an inflatable packer and grouting valve on the base immediately above the screen seal.

- After correct positioning of the liner has been verified by downhole video camera inspection a grouting string with a series of inflatable packers is run into the new liner.

- Inflation of all string packers allows the lower two packers to isolate the inflation port for the liner packer. This packer is then inflated by pressurising this isolated zone via a hose run from the surface.

- With the liner packer inflated, the productive zone of the bore is fully protected so the liner can then be grouted into the old casing by pumping cement grout down the grout string and via the grouting valve into the annulus.

- Cement in the string is displaced into the annulus by pumping water after the cement. Note that the top string packer allows the liner to be pressurised to prevent collapse during cementing operations.

- Deflating the top packer isolating the grouting valve allows further flushing of the grout string and liner bore via a choked outlet through the top string packer.

- After waiting for the cement to reach initial set, the string packers are deflated and the grouting string is removed.
- The pump can then be re-installed by others as required.

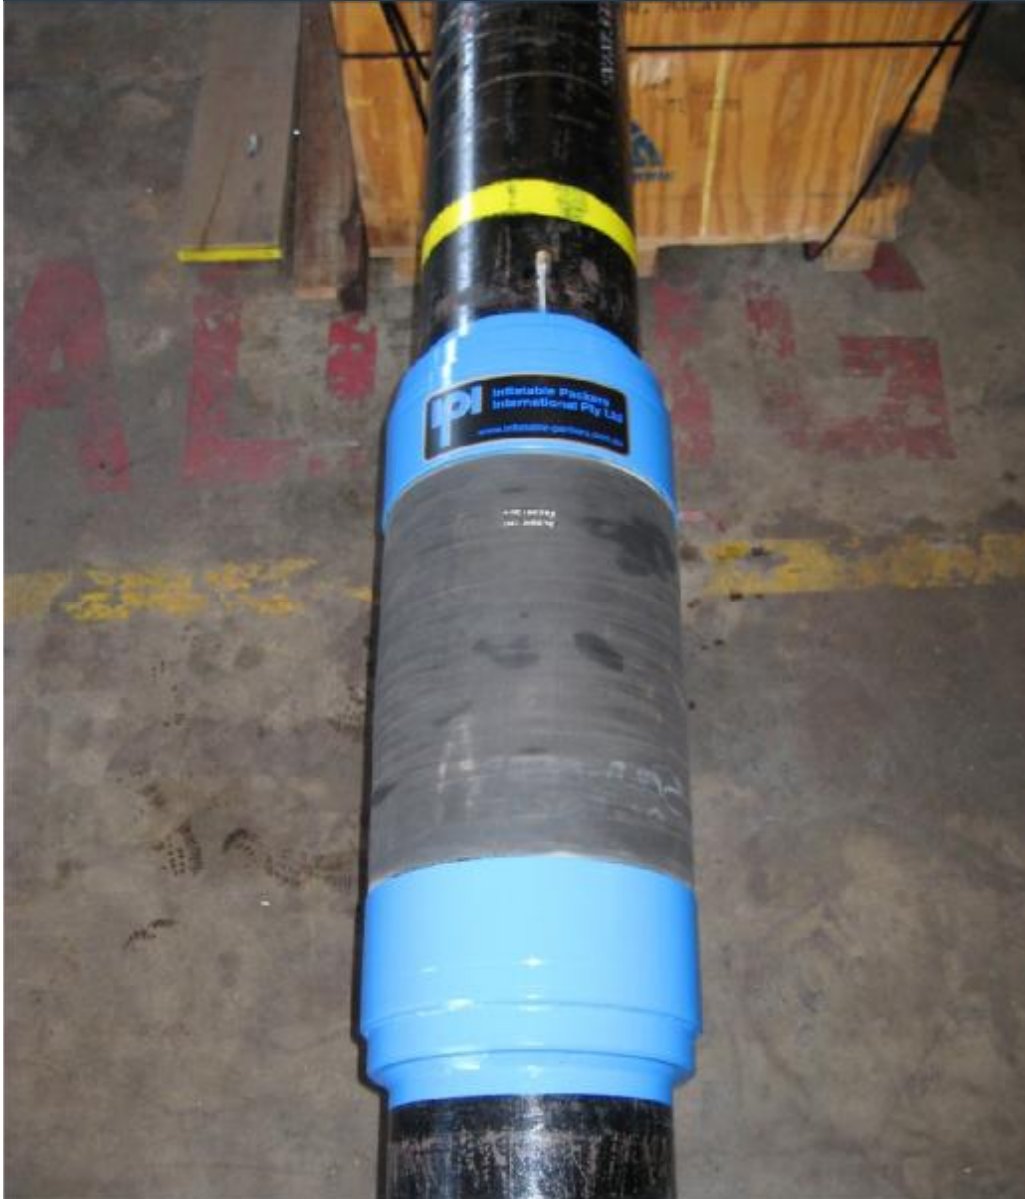
Slip-on ECPs

These packers are built with internal diameter large enough to allow them to be slipped onto a joint of casing and then be secured in place using a high strength, filled epoxy resin.

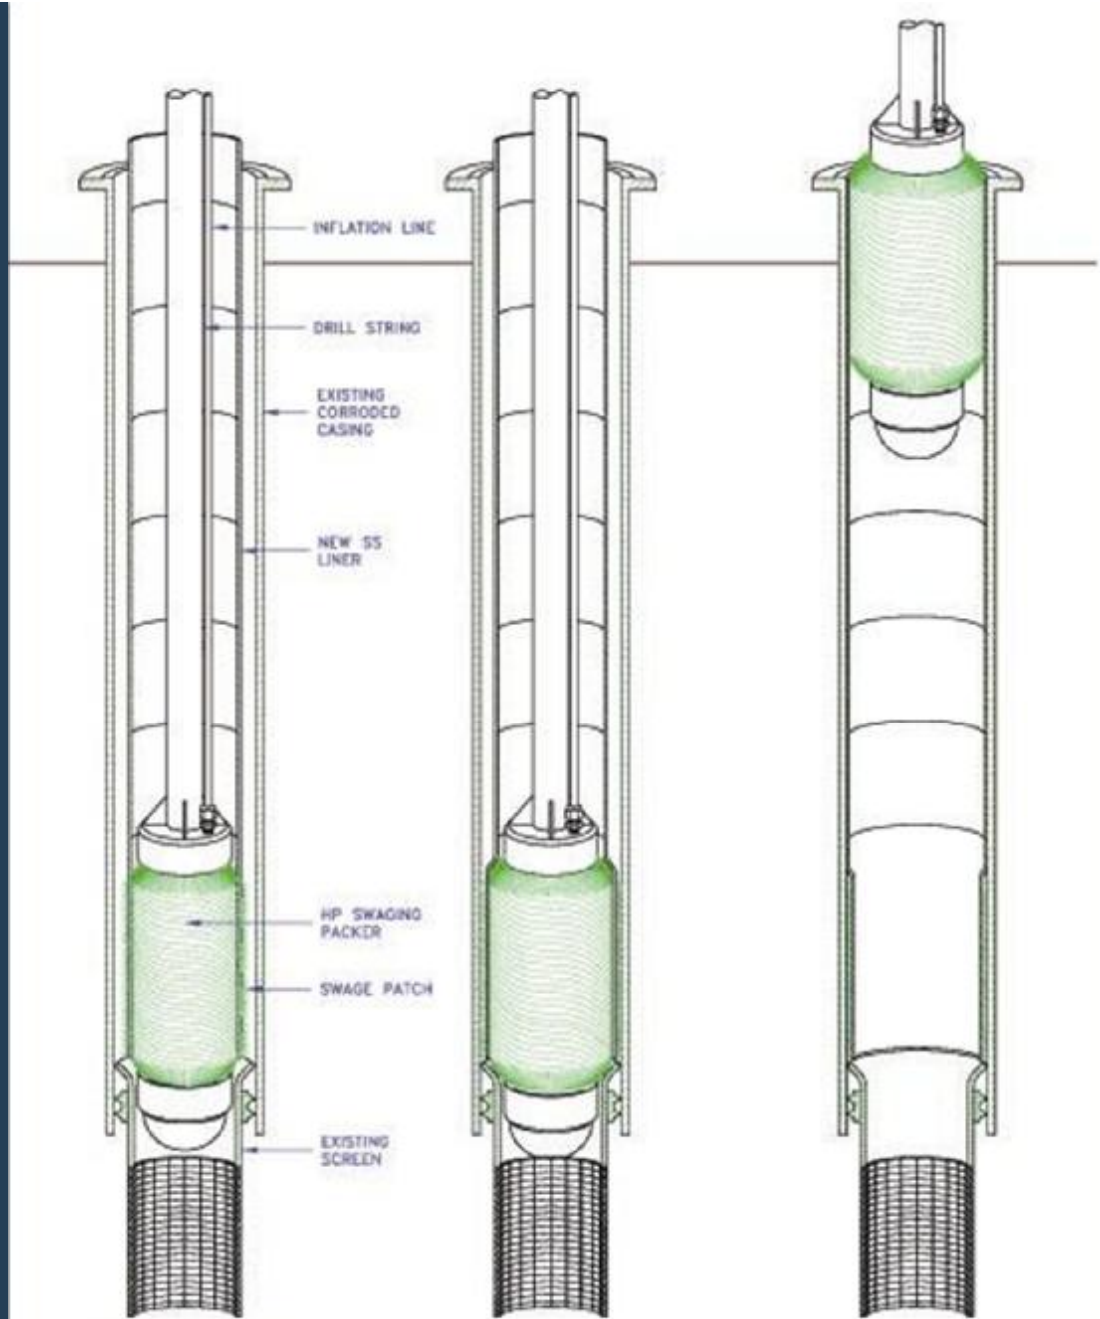
- Our swaging method may also be used to install a liner in a well with an absolute minimum of ID loss.
- The basic process is illustrated on the following slide.

RUN IN NEW LINER
AFTER WELL CLEANING
& VIDEO INSPECTION

SWAGE BOTTOM PATCH

CONTINUE SWAGING
TO SURFACE

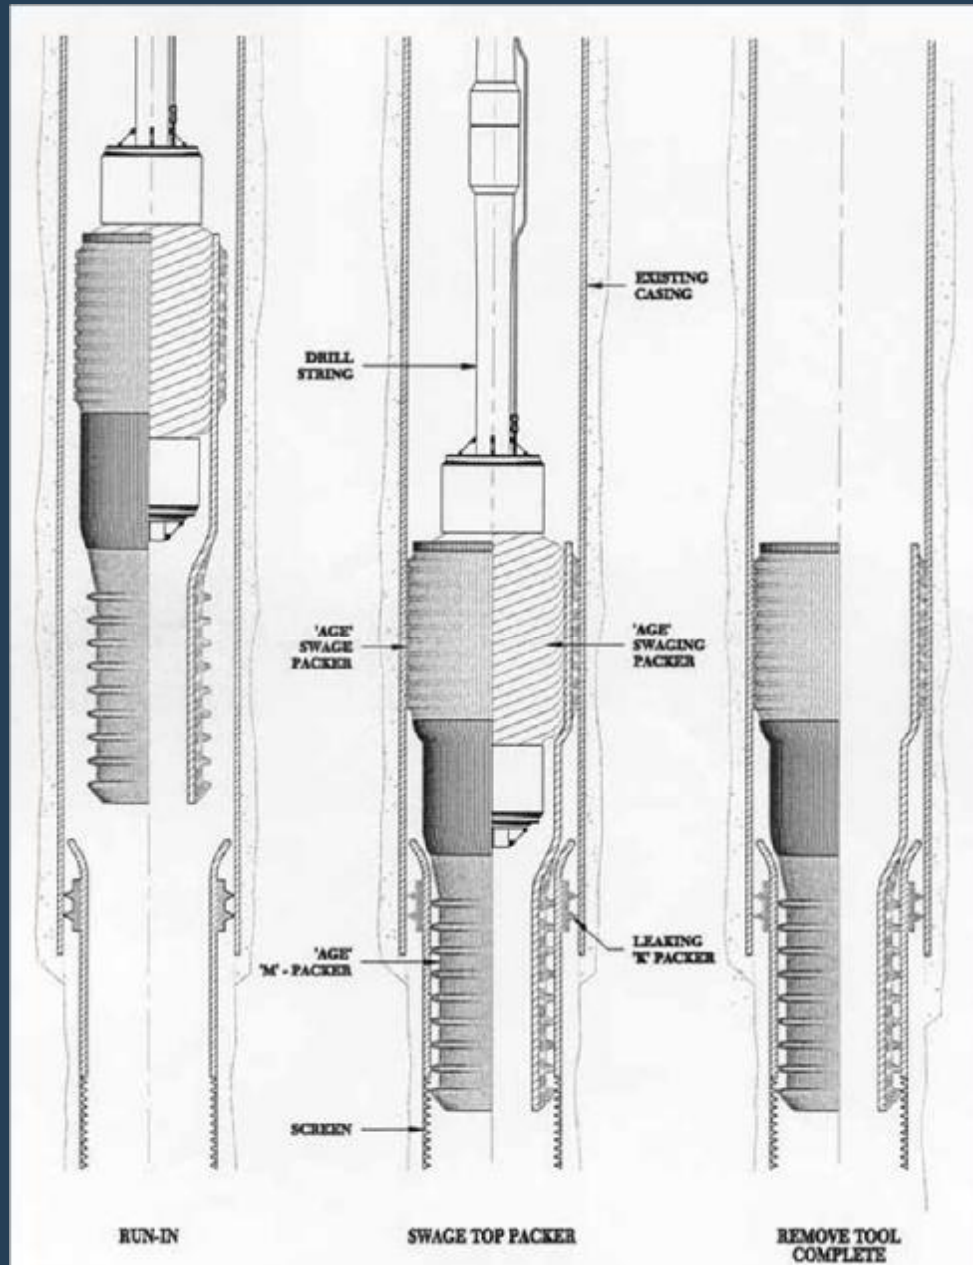
Swaged Screen Packer Repair

- Our swaging method may also be used to repair a leaking screen to casing seal packer as shown on the next slide
